## FIRES IN THATCHED BUILDINGS

Updated to include the 2010/2011 heating season, 61 fires in total

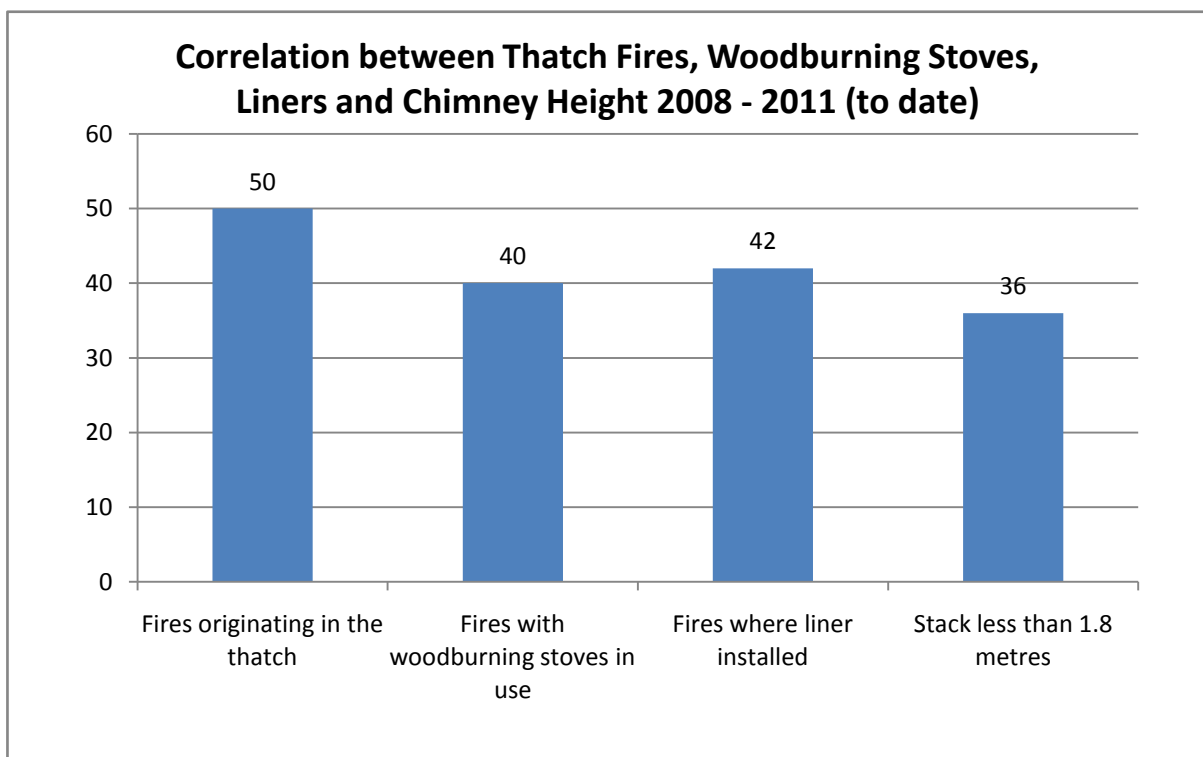
**Figure A**

Flue liners were present in all 40 cases involving wood burning stoves (see figure A) and one open fire was connected to a liner, which was to be expected since in recent times a liner has almost always been fitted along with the stove. In 36 of those 40 cases, the chimney was less than 1.8 metres high, the minimum height specified in the Building Regulations 2000 for combustible roof coverings, including thatch.

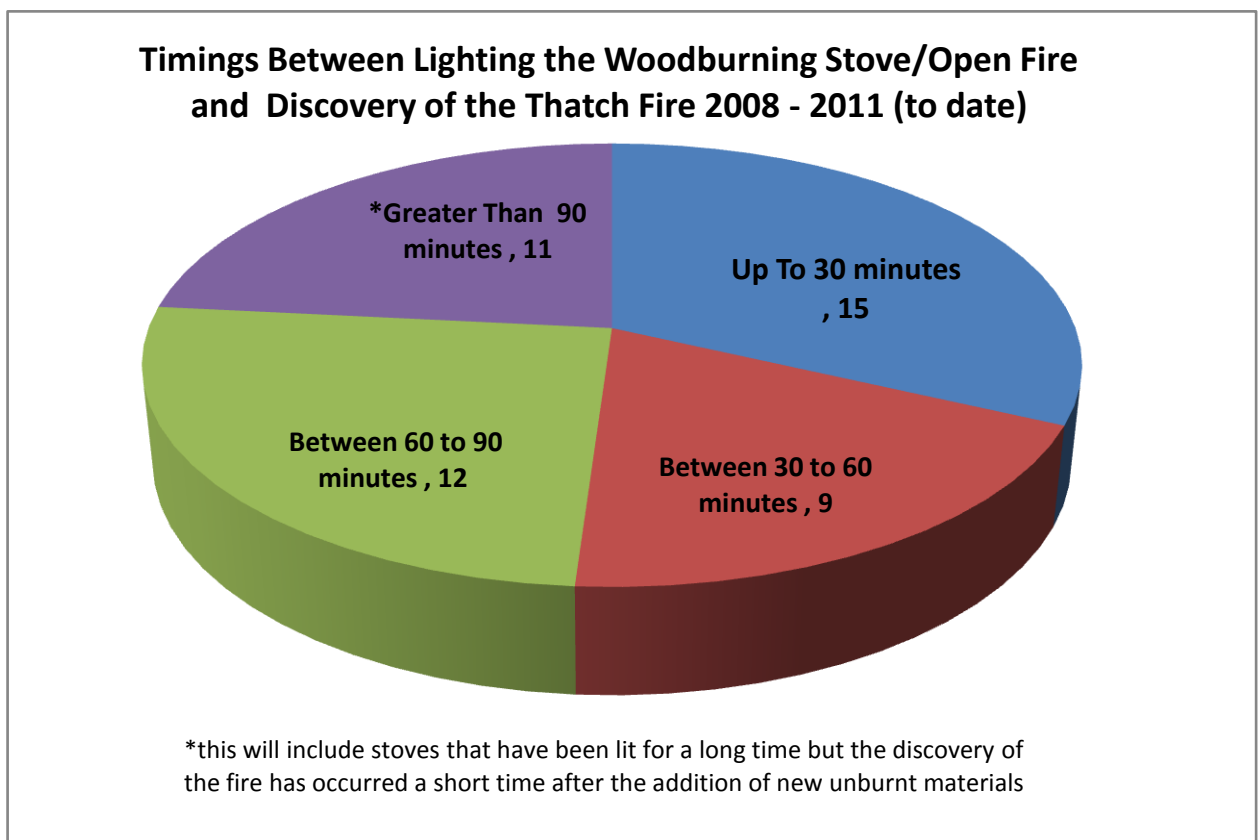
**Figure B**

The time between the lighting of the stove or fire and discovery of the fire was also examined and out of the 40 fires, 15 occurred within 30 minutes of lighting, 9 between 30 and 60 minutes and 12 between 60 and 90 minutes (see figure B). **Thus a total of 36 of the 40 fires occurred within 90 minutes of lighting, a very striking statistic.** Moreover, in a number of other instances, fuel had been added to an existing fire within 60 minutes of discovery. A further factor was that in 5 cases a chimney fire was reported.

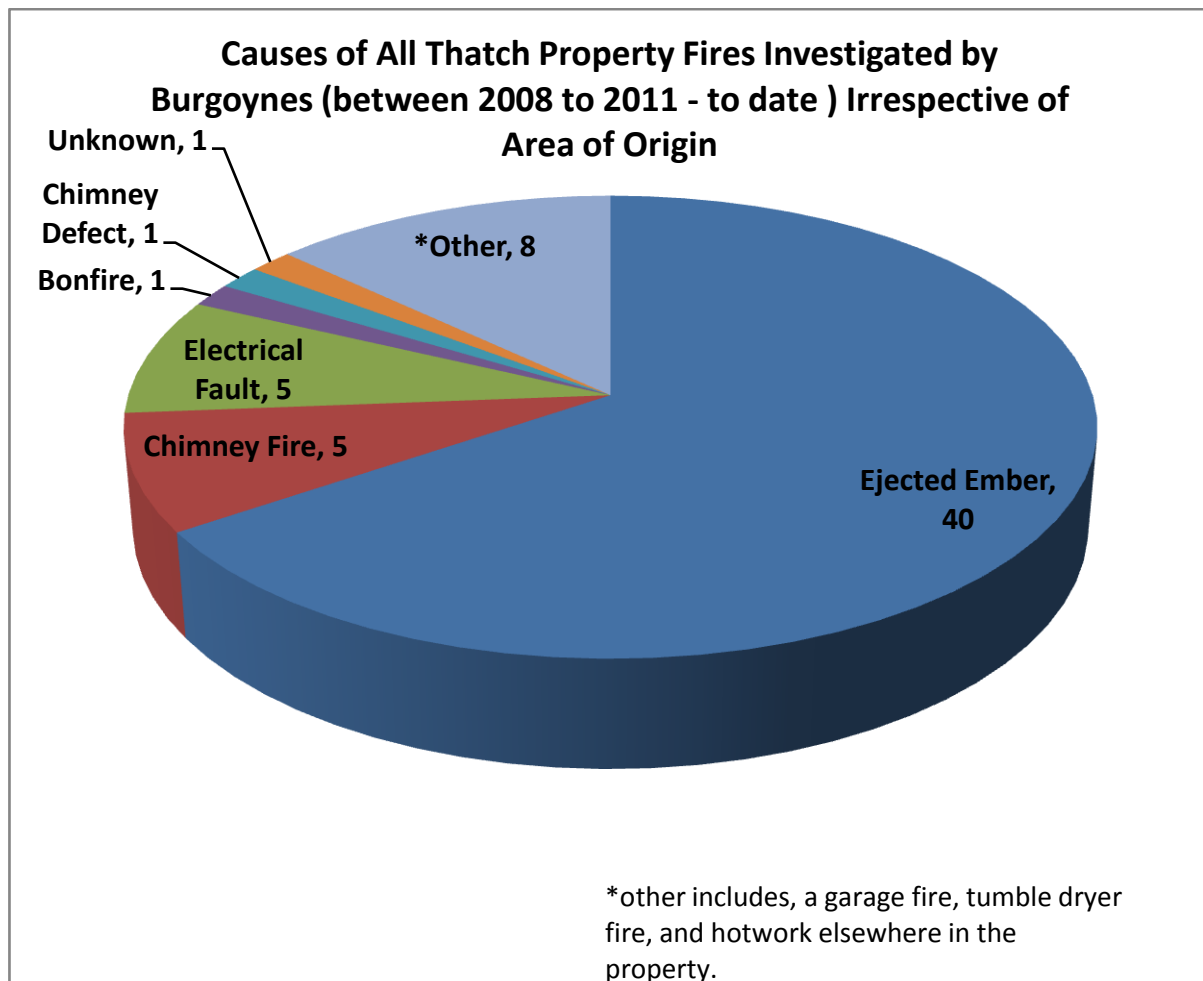
**Figure C**

Looking at all of the 61 investigations (see figure C), by far the most common cause identified by Burgoyne's was an ejected ember (40), with the next most common being chimney fire (5) and electrical (5). A chimney defect was only identified in one case.
