FIRES IN THATCHED BUILDINGS

A survey of 148 fires between December 2008 and May 2016

UPDATED FOR THE 2015–2016 HEATING SEASON

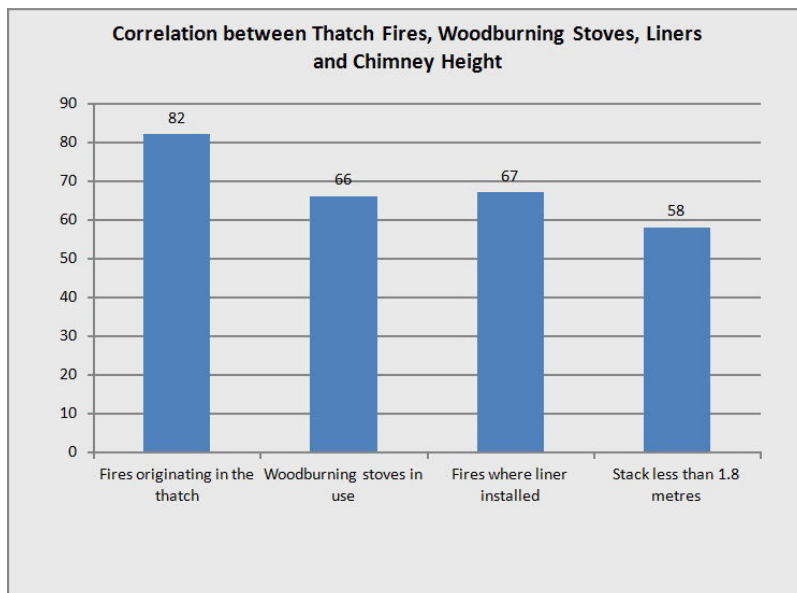
Figure A

Flue liners were present in all 67 cases involving wood burning stoves (see figure A), which was to be expected since in recent times a liner has almost always been fitted along with the stove. One open fire was also connected to a liner. In 58 of those 67 cases, the chimney was less than 1.8 metres high, the minimum height specified in the Building Regulations 2000 for combustible roof coverings, including thatch.

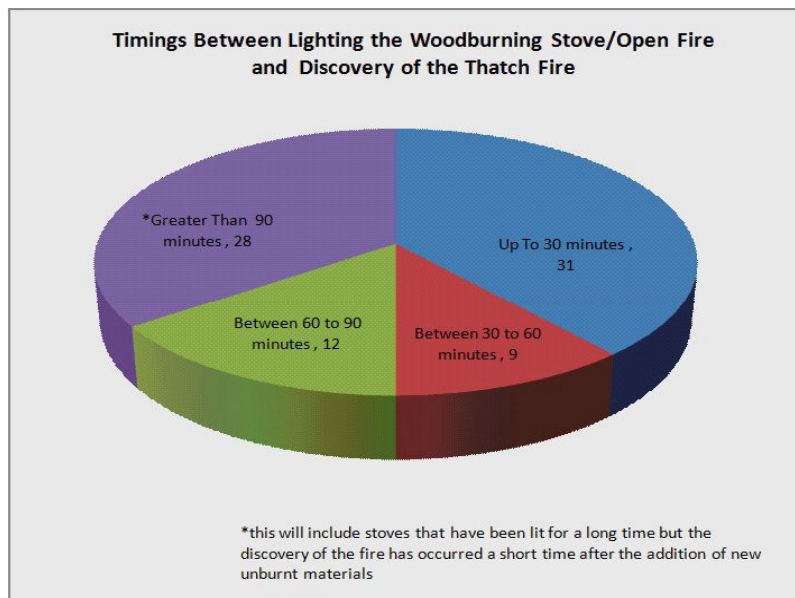
Figure B

The time between the lighting of the stove or fire and discovery of the fire was also examined and out of the 80 fires for which timings were known, 31 occurred within 30 minutes of lighting, 9 between 30 and 60 minutes and 12 between 60 and 90 minutes (see figure B). **Thus a total of 52 of the 80 fires occurred within 90 minutes of lighting, a striking statistic.** Moreover, in a number of other instances, fuel had been added to an existing fire within 60 minutes of discovery. A further factor was that in 11 cases a chimney fire was identified as having occurred.

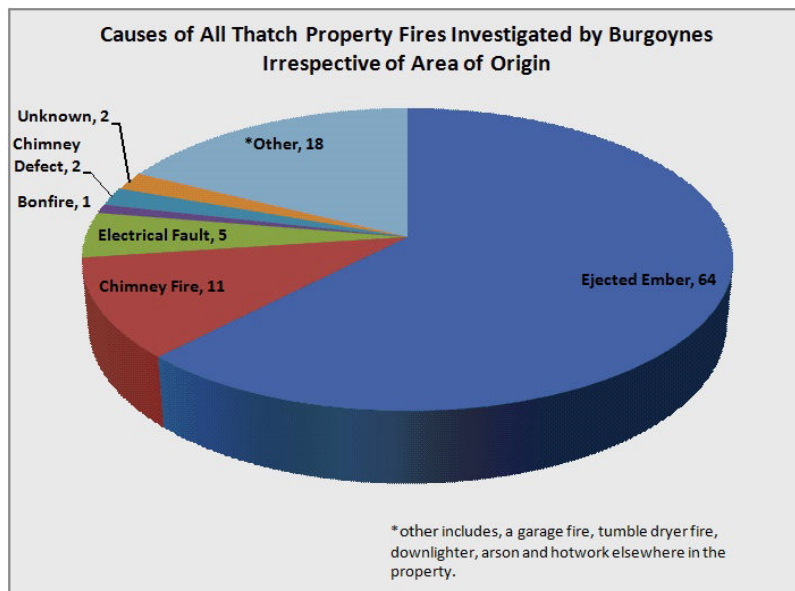
Figure C

Looking at all of the 103 investigations (see figure C), by far the most common cause identified by Burgoyne's was an ejected ember (64), with the next most common being chimney fire (11) and electrical (5). A chimney defect was only identified in 2 cases.
